Booster Neutrino Beamline Status

Thomas R. Kobilarcik

Neutrino Beams and Instrumentation, 2019

22 October 2019

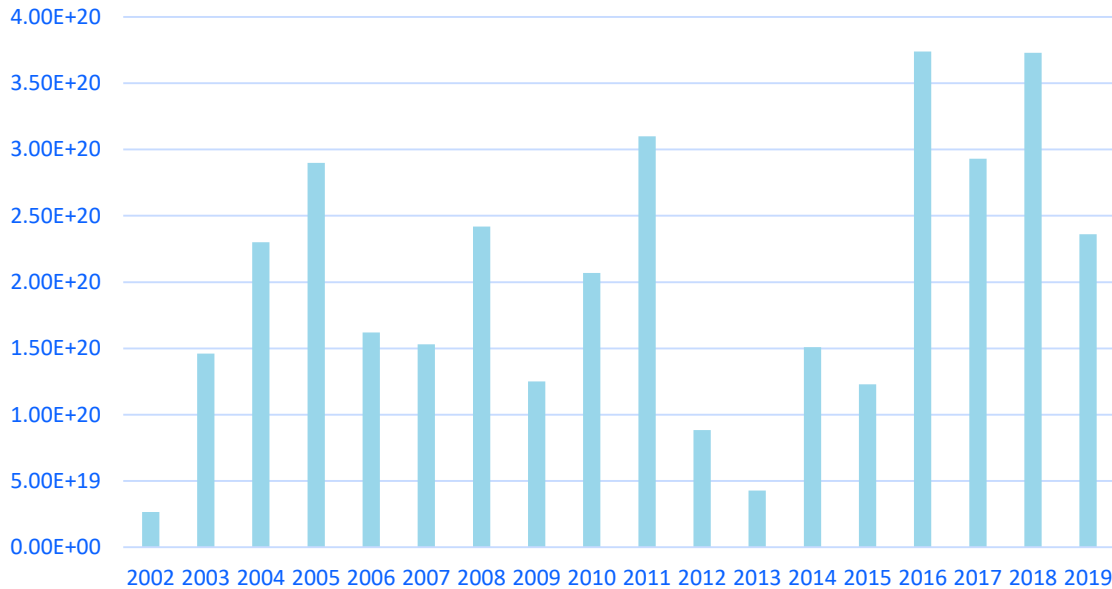
Annual Protons on Target

Since turning on, BNB has transported $3.6\text{E}21$ protons

The horns have pulsed $\sim 3/4$ of a billion times

BNB is assessed for 5×10^{12} protons per pulse at 5 Hz average

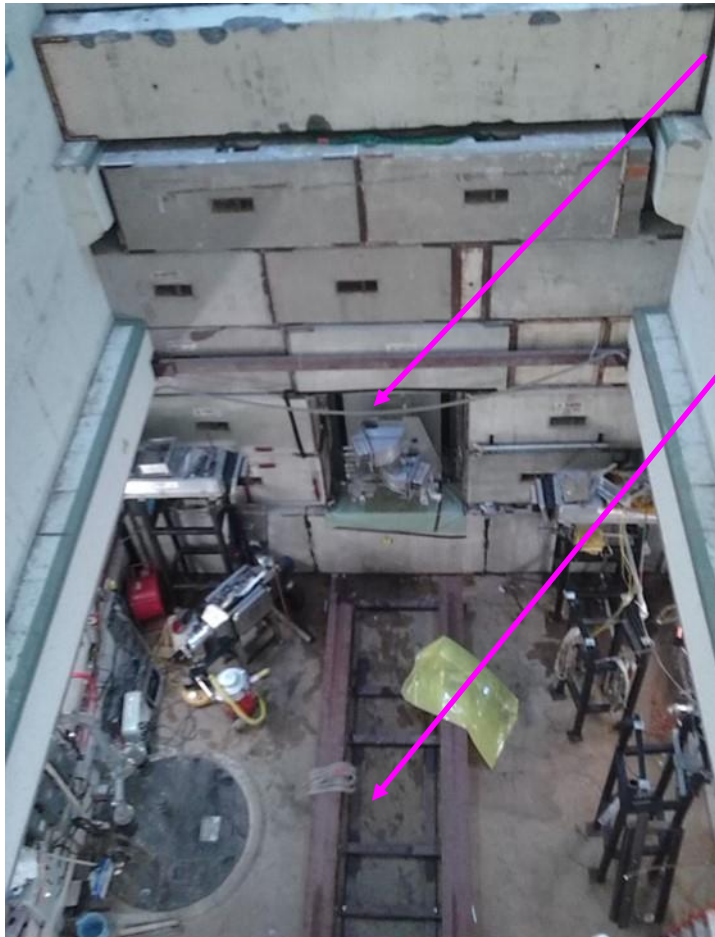
Horn #2 Failed

Horn is buried in target pile

Part of beamline is removed to allow for working space.

Horn is transferred directly into coffin, reducing exposure

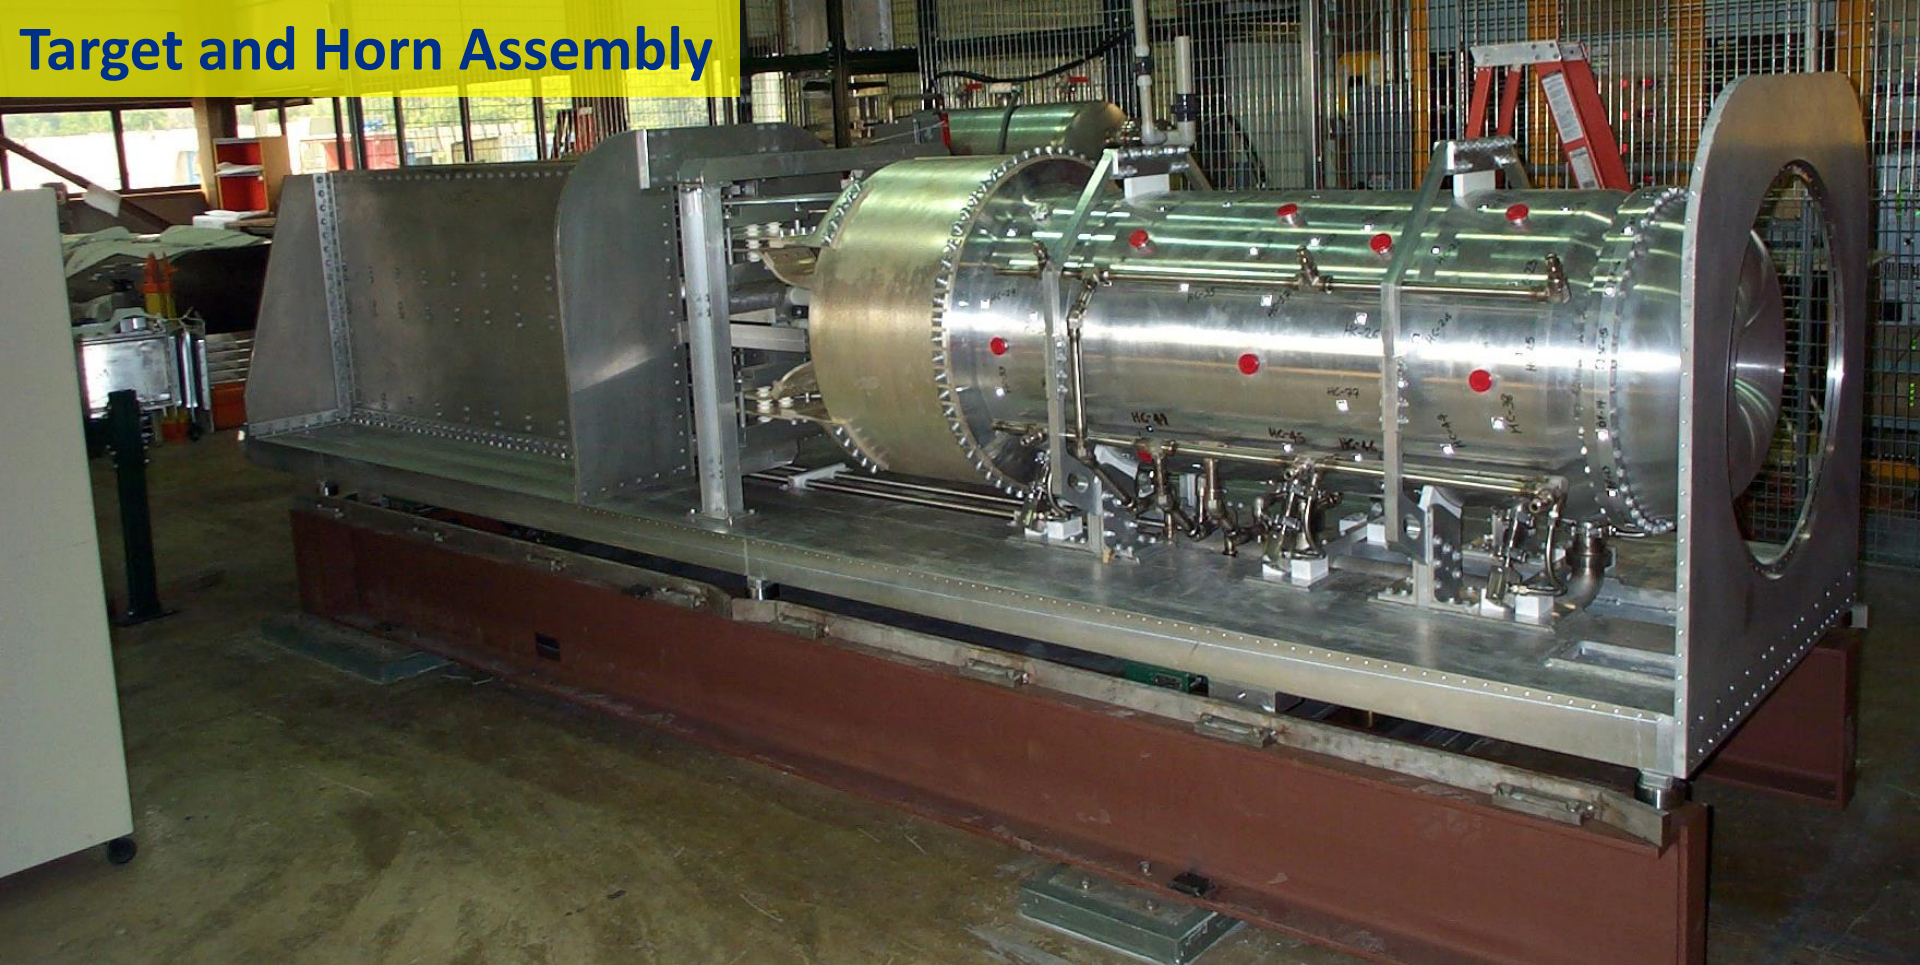
Target and Horn Assembly

Target/Horn Assembly sits on an alignment module in the target pile
When we attempted to remove horn, found that alignment module no longer worked –
needed a new alignment module

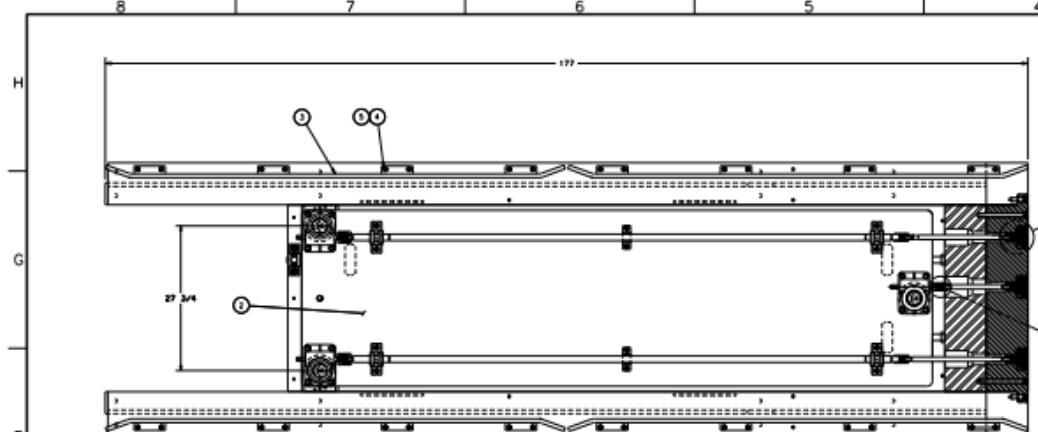
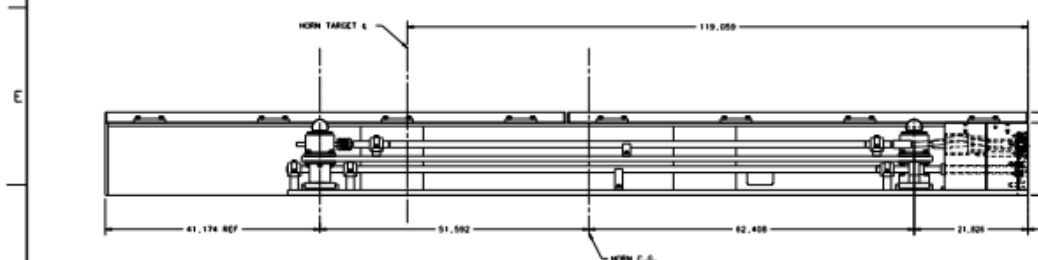
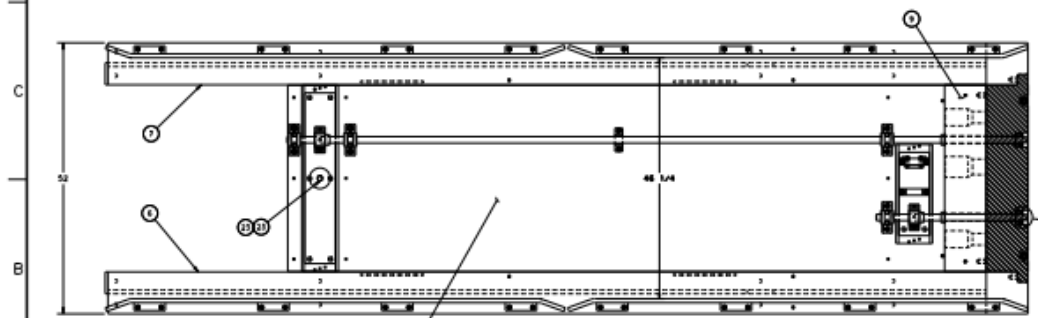
SECTION A-A
(SECTION ONLY THROUGH ITEM #6 & #9)

ITEM #6 REMOVED FROM THIS VIEW

SECTION B-B
(SECTION ONLY THROUGH ITEM #6)

Old alignment module used commercial screw jacks.

After 15 years, parts corroded, grease hardened, nothing worked.

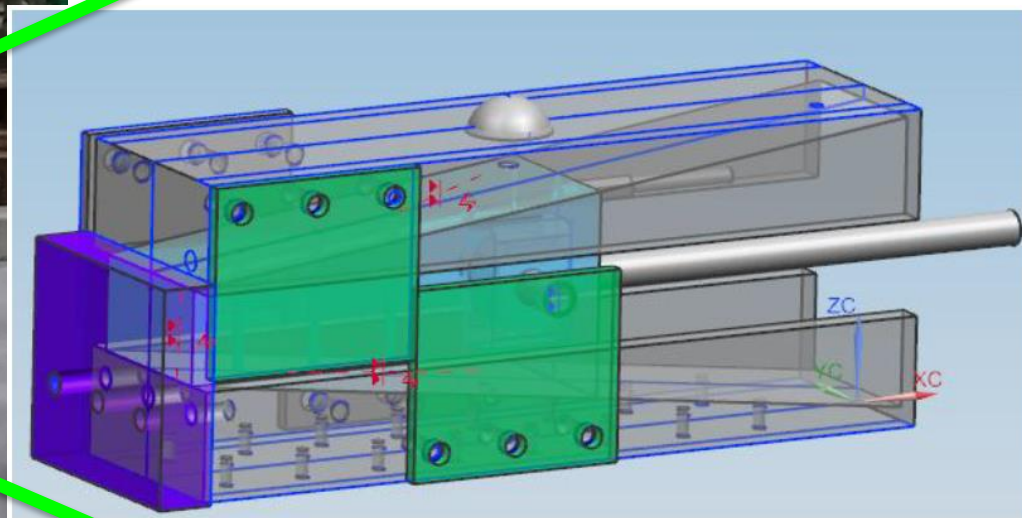
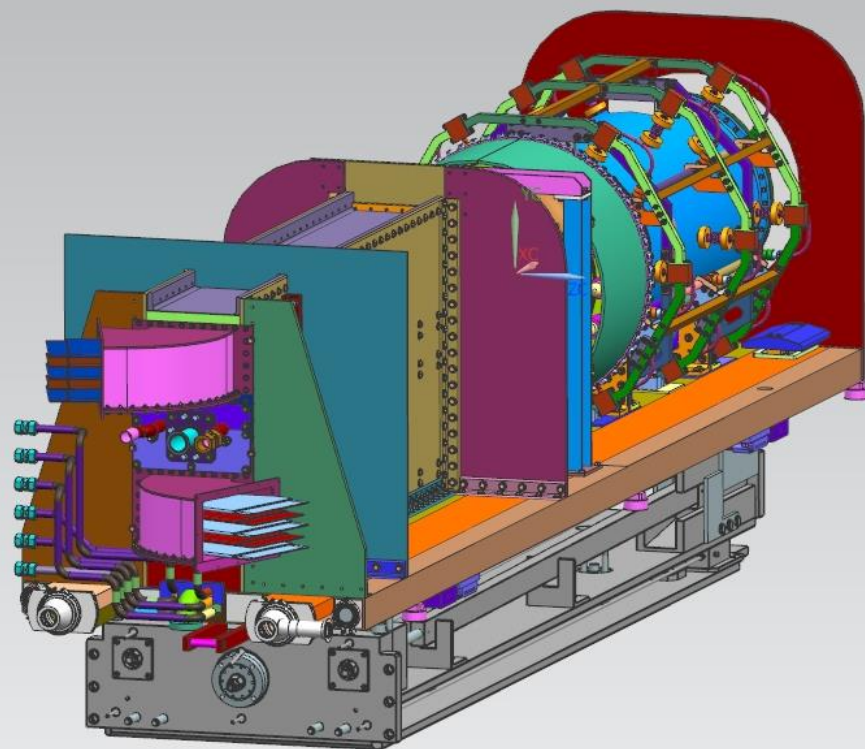
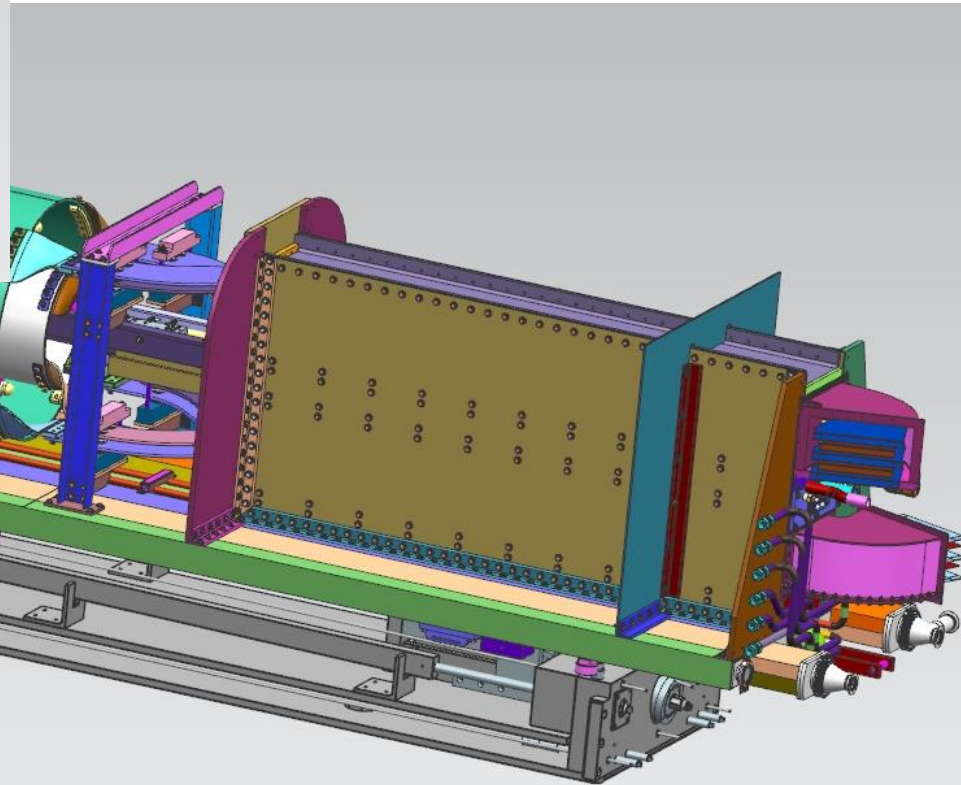
New Alignment Module

Brackets to hold push rod

Moving parts are anodized
and have provision for air
bearing

Lifting Wedge

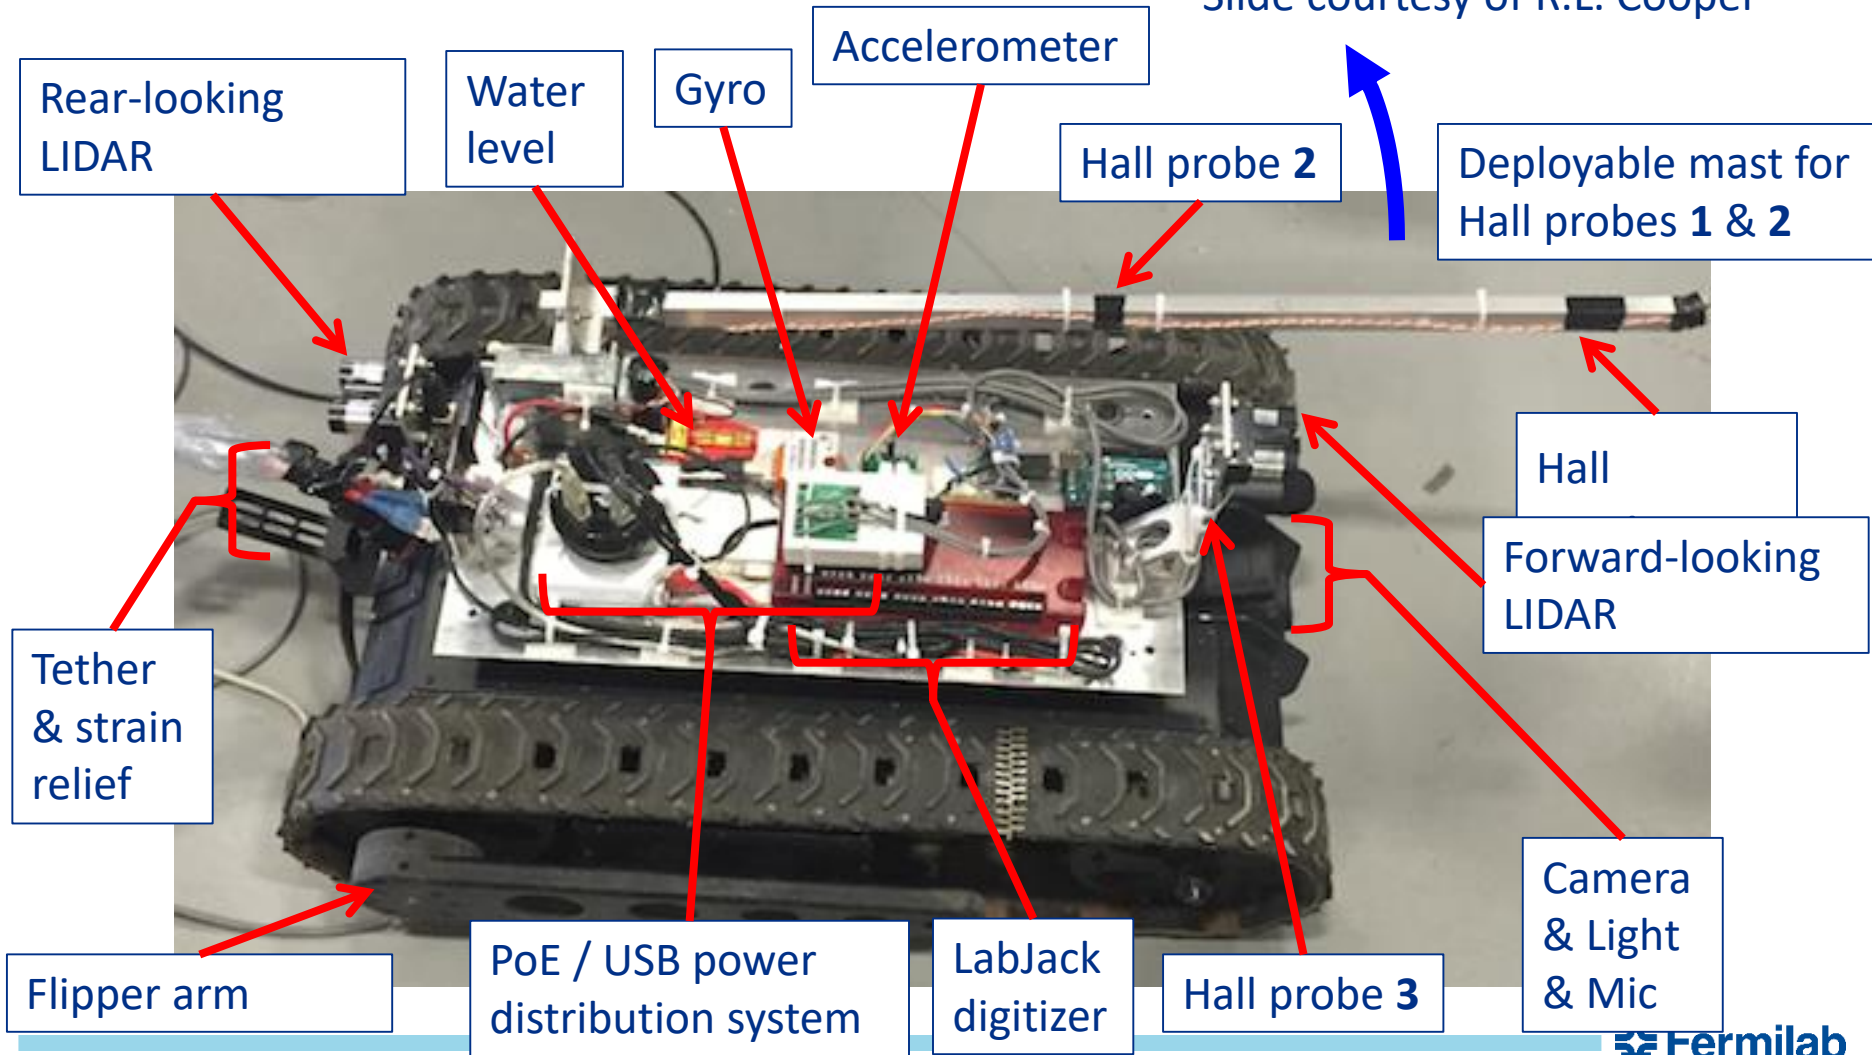
FRED*: Instrumentation Package

*Finding Radiation Evidence in the Decay pipe

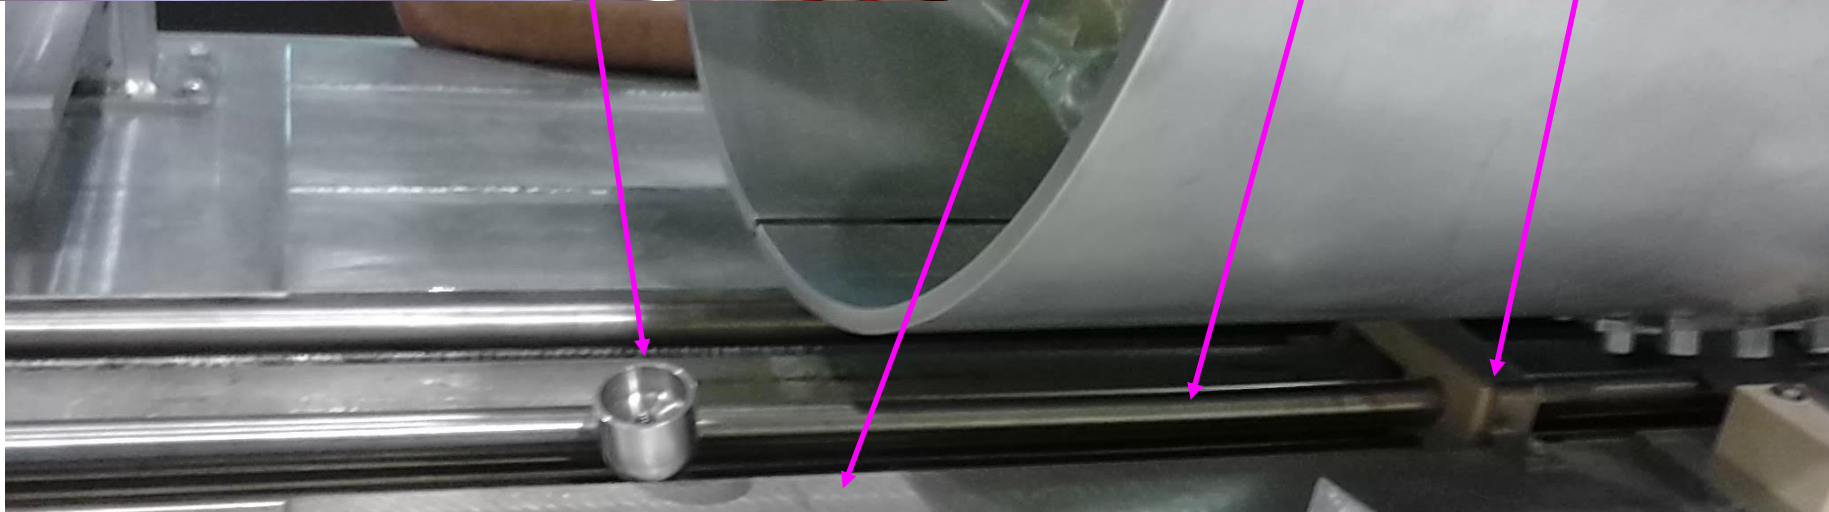
About a month into running, horn shorted to ground. This was caused by a corona cap that came loose and fell off. (Cap reduces corona cause by screw threads.)

Horn box
(ground)

water drain line
(at voltage)

ceramic insulator

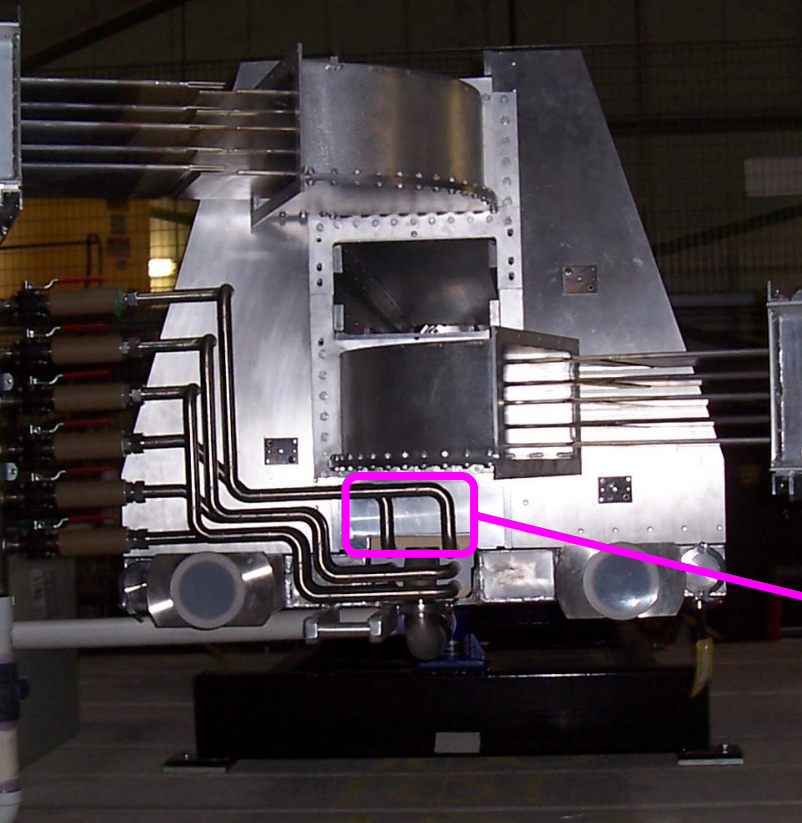
Hole in horn box through which the corona cap was removed.

Access port is now a feature of BNB horns

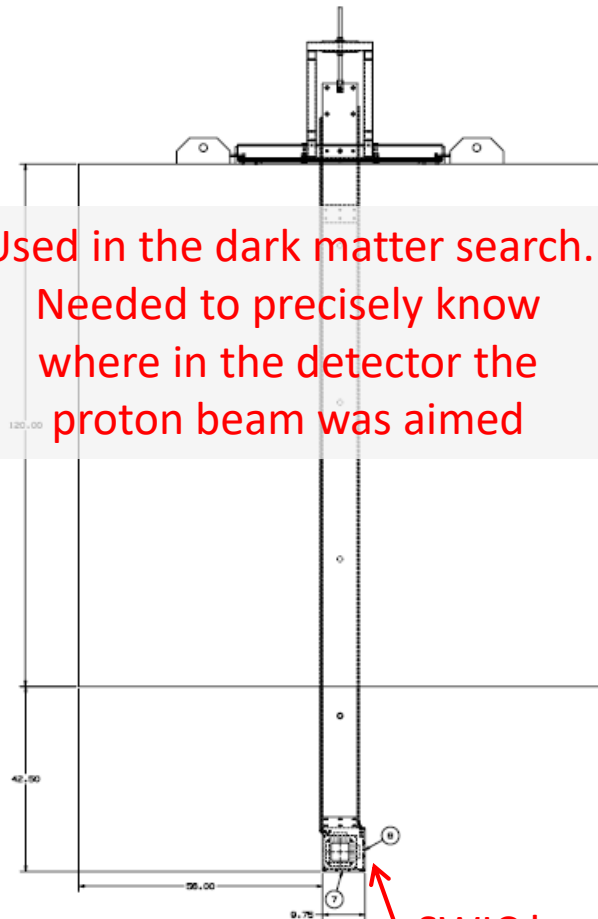
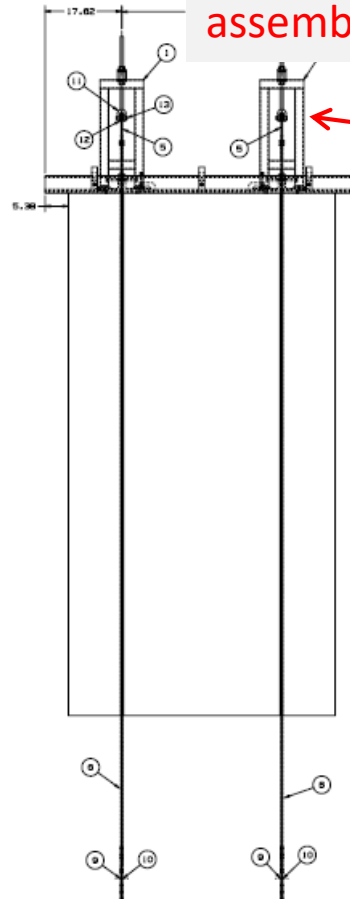
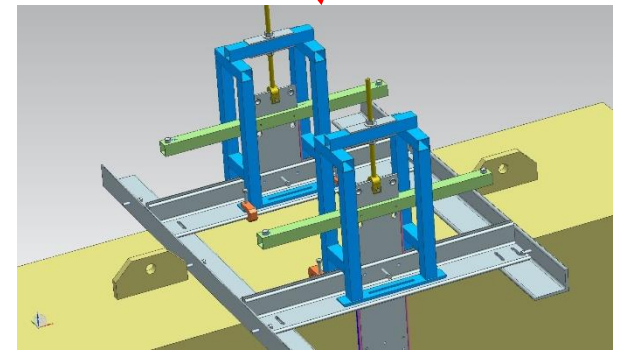
Temporary Profile Monitors at 25 m Absorber

Profile monitor wires are referenced to fiducials on top of hanger. Referencing can be done in the shop with entire hanger assembled.

Used in the dark matter search.
Needed to precisely know
where in the detector the
proton beam was aimed

Hanger sits on top of module.

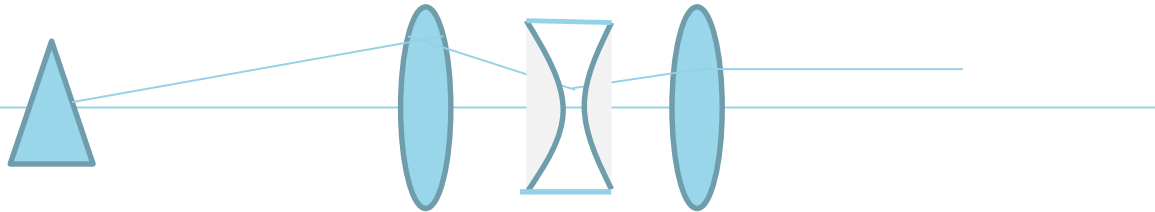
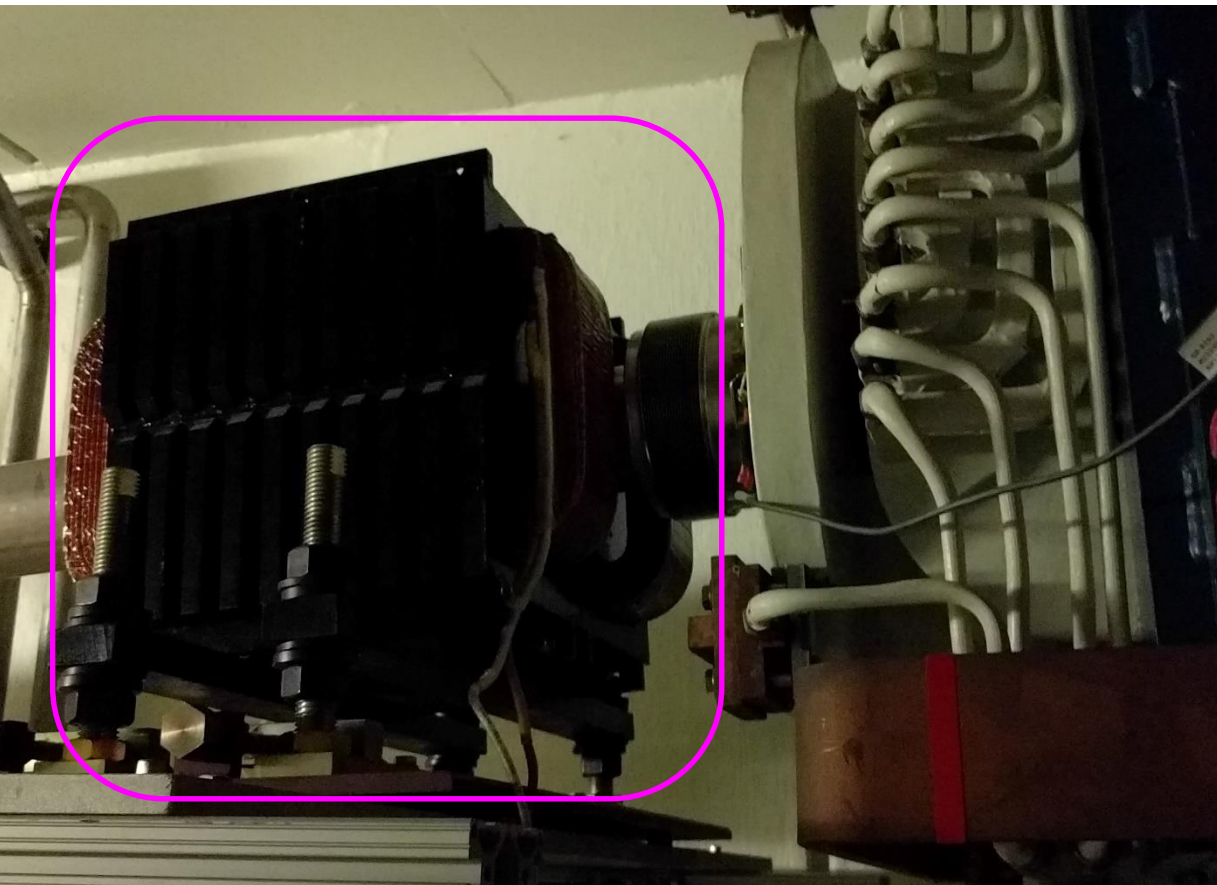
Rapid Trim Magnet for Off-Target Running

Installed at upstream focal point of final focusing triplet.

(Converts an angular kick to a parallel offset)

Able to ramp up and down in $< 1/30$ of a second (half a Booster cycle).

Can be triggered independently of horn – not rate limited by horn.

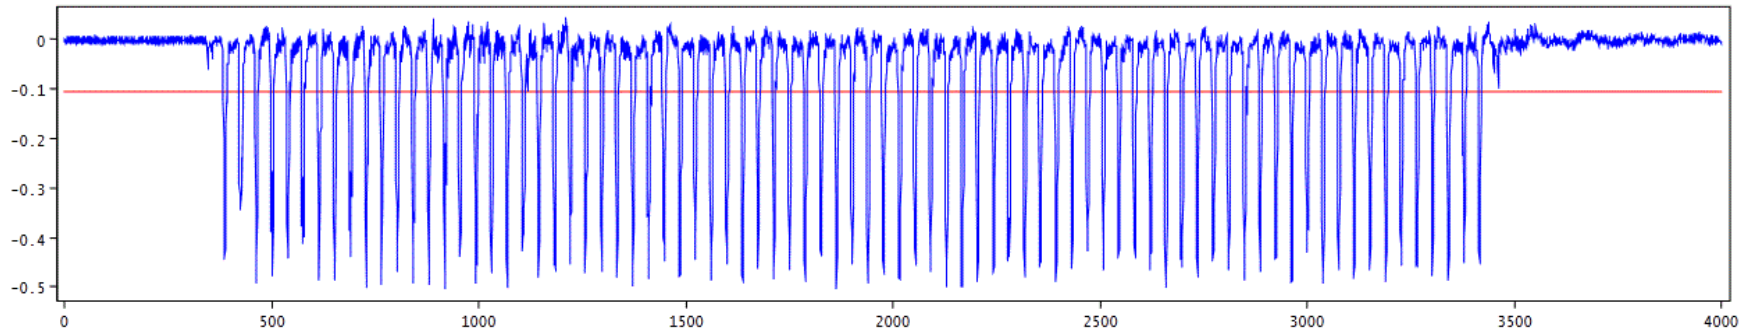
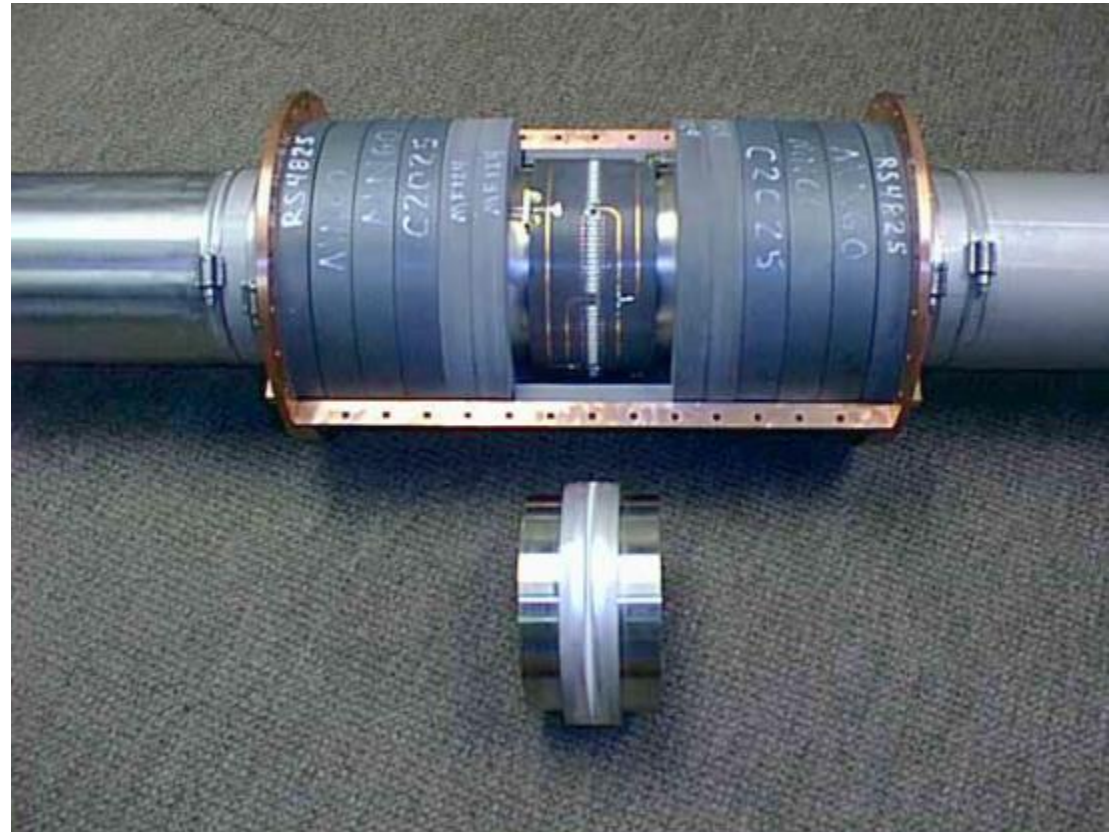
Resistive Wall Monitor Put to Use

2 GHz sample rate over entire spill.

Data is recorded every pulse, and is available through the Intensity Frontier Beam Database.

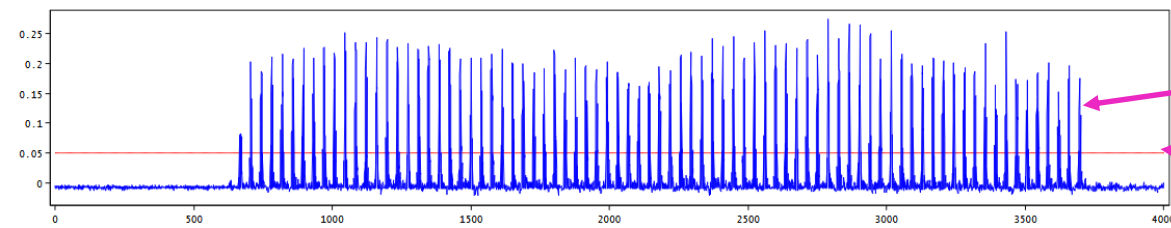
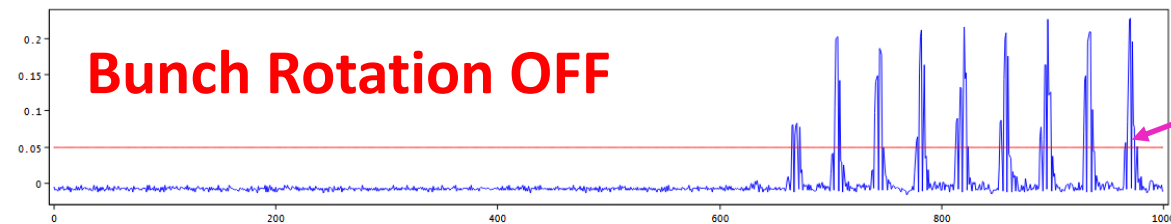
Bunch Rotation OFF

Individual bunches

Trigger threshold

Problem with digitizer –
drops every fourth record

Digitizer measures
voltage induced by

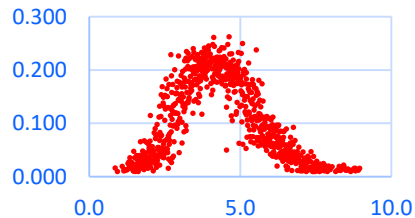
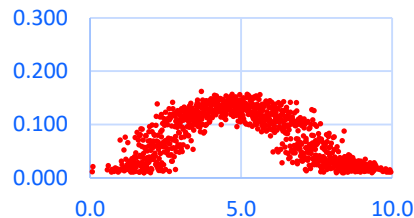
Bunch Rotation OFF

(horizontal units: ns)

Bunch Rotation ON

Based on 10 measurements each with bunch rotation on and off, bunch rotating the beam increases the 1-sigma time-spread at the resistive wall monitor from 1.48 ± 0.03 ns to 2.15 ± 0.13 ns.

Increase time spread, but decrease momentum spread.

Beam is smaller in high-dispersion regions → lower losses.

Under good conditions, the hourly rate could increase by ~7%.

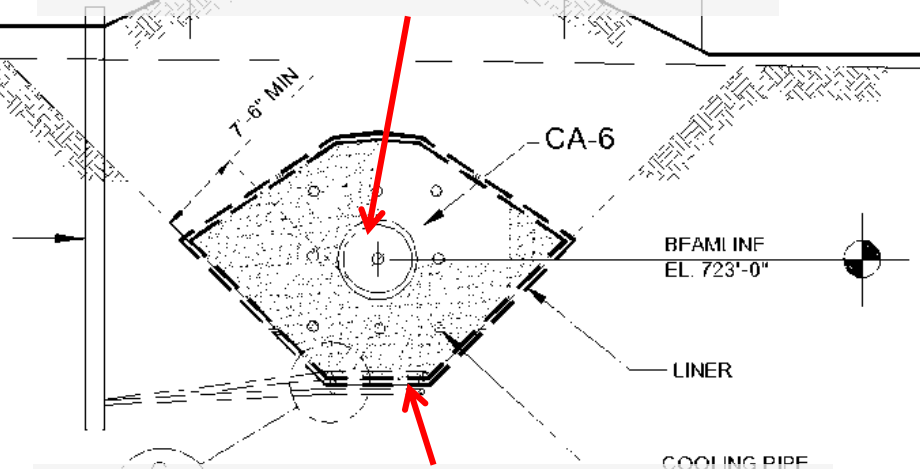
Ground Water Problems

Decay pipe buried in 12 to 15 feet of aggregate.

Aggregate is surrounded by two impermeable liners.

Early on we found a leak in the impermeable liners

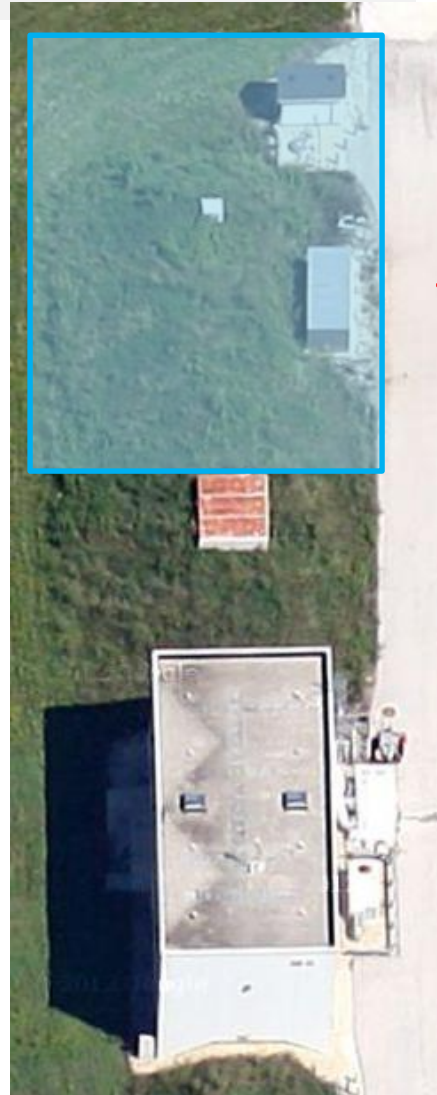
Install high-density polyethylene cover to keep water away from liner.

This did not work, either

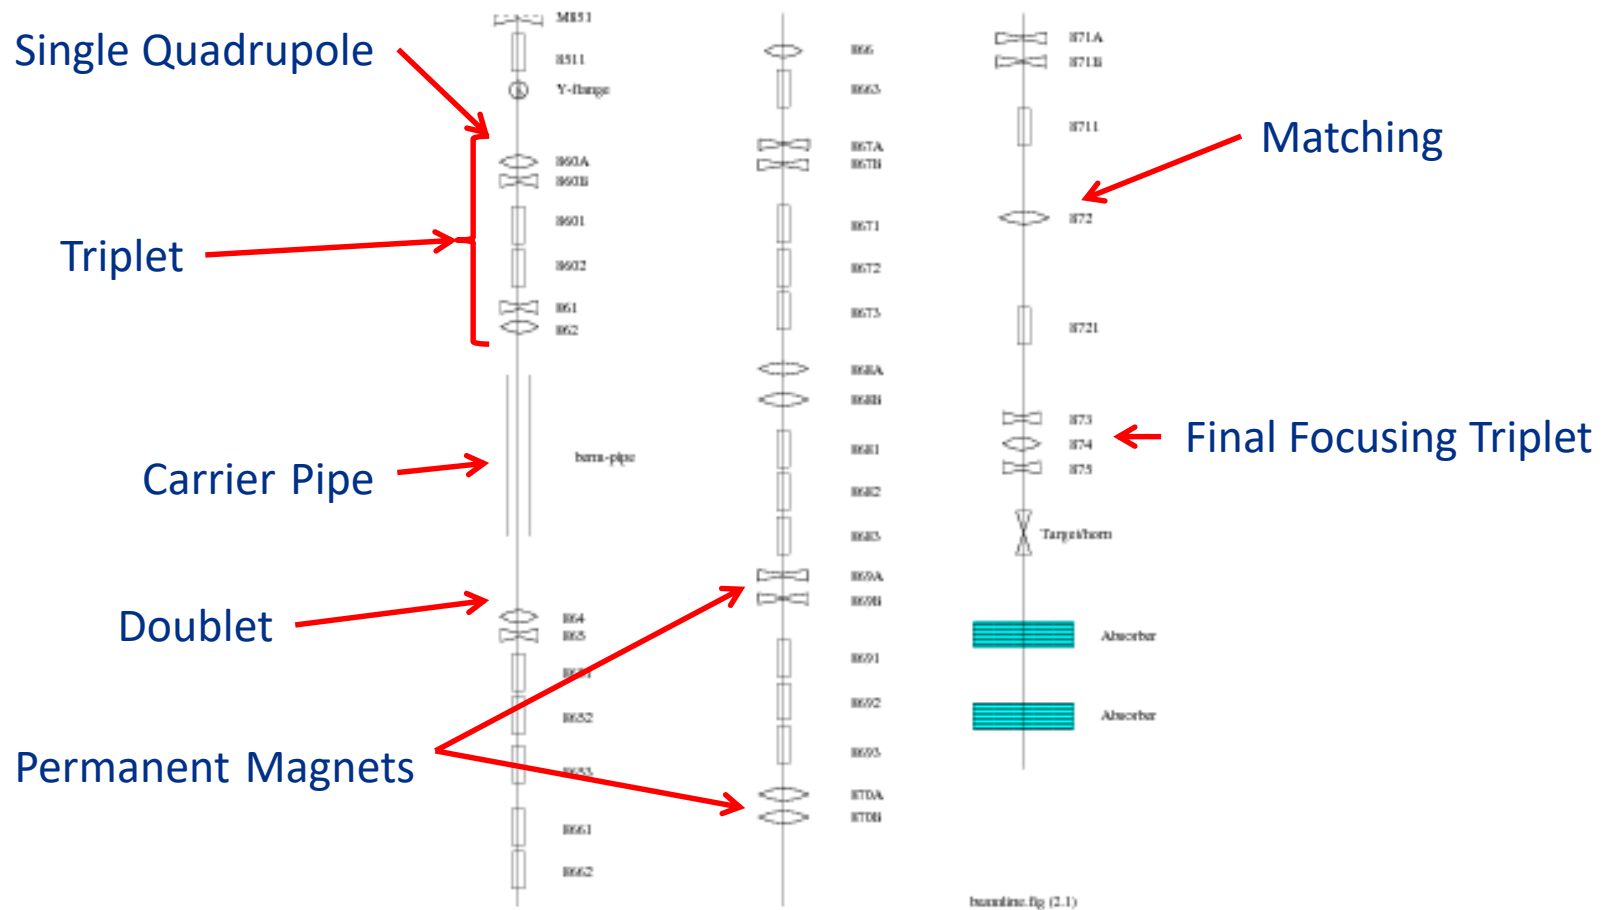
Beamline -- Schematic

Figure 2.1: Beamline schematic and function. Elements are listed in Table 2.1.
